LIGHT INDUSTRIAL CASE STUDY

HOUSEBOAT MARINE DECK

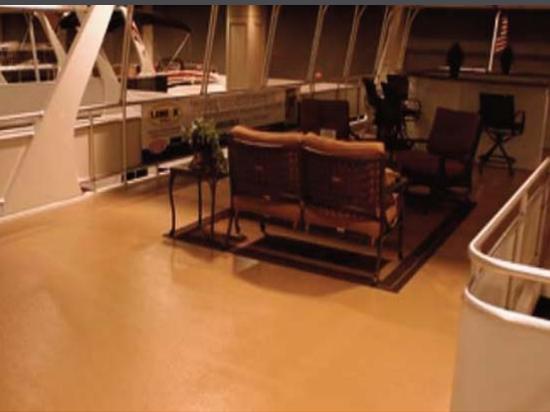
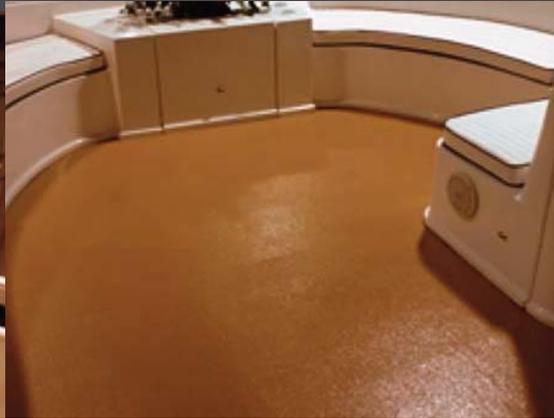
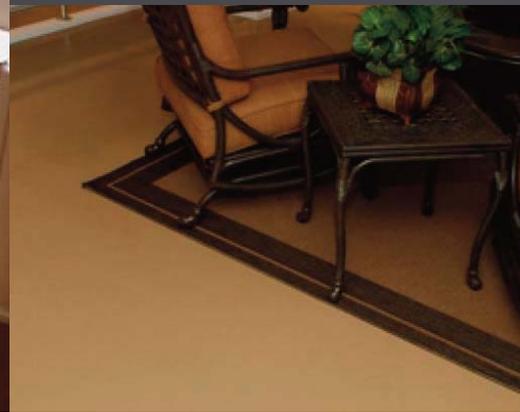
The deck of the houseboat was coated with LINE-X XS-100 and LINE-X XTRA to provide strength, durability and aesthetic value.

The wooden deck was sanded and coated with 125 mils (approx. 1/8th of an inch) of LINE-X® XS-100, colored according to the owner's specifications. The coating was then topped with LINE-X® XTRA to give it a long lasting, glossy, color-coded finish. Total application time was approximately one quarter that of traditional gelcoat finishes.
