INDUSTRIAL FIELD REPORT

SEWAGE WATER CLEANING - TANKS

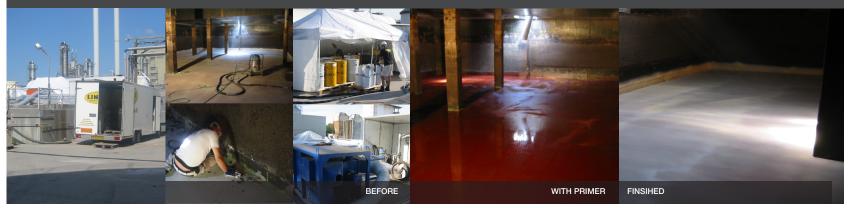
LINE-X® XS-350 was sprayed 3.18 mm (1/8 inch) thick onto primed concrete creating a monolithic, impervious protective lining with tenacious adhesion.

The difference in thickness was less than 4 % calculated over all 900 m2 thanks to our skilled applicators.

Each tank was completed in one week and back in service 12 hours after application.
